A Concrete Example

Carbon Fiber Repair for Thrust Restraint Upgrade of 84-in. PCCP

By Paul Acosta, Rasko Ojdrovic & Anna Pridmore

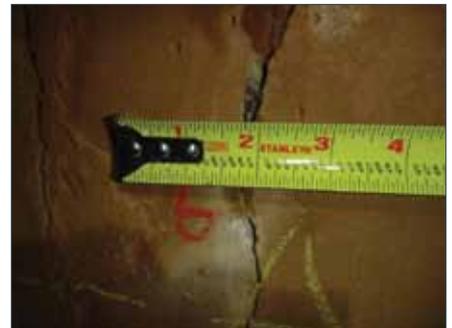
A more thorough investigation revealed circumferential cracks in the

During an internal visual inspection in 2013, Tucson Water crews identified a pipeline leak as water penetrating into the 84-in. PCCP wall from the outside. Photo courtesy of Hector Posada, Tucson Water.

vicinity of elbows. The Tucson team concluded that more information was needed and their engineering partner, Simpson Gumpertz & Heger, performed a failure analysis based upon this. The study concluded that within a pipeline span of approximately 200 lf, encompassing two adjacent 45 degree bends, did not have adequate thrust restraint and the pipe was unable to resist the thrust forces acting on the bends.

ously. A key aspect of design was that the longitudinal deficiencies within the 84-in. pipeline segment were found to be caused by inadequately installed thrust restraint. The longitudinal forces acting on the pipeline were not properly resisted and the pipe segments developed circumferential cracks at the pipe joints where sections were pulled apart by thrust forces.

Following repair options analysis, CFRP lining was selected to perform a repair scope of 165 lf of the 84-in. PCCP. CFRP was chosen because the pipe could be strengthened internally, requiring no excavation, and could be designed and installed rapidly. This allowed Tucson to place the pipeline back in service within the allotted outage window. The CFRP upgrade was completed on an emergency basis because the time required for a routine replacement made this option infeasible.

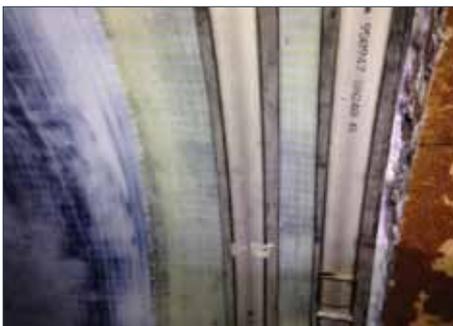
The best practice for end detailing of CFRP systems includes a specially designed leak-tight connection through a tie-in at the steel cylinder portion of the PCCP. Photo courtesy of Hector Posada, Tucson Water.

leaks occurred in the pipe, the joint repairs and CFRP system end termination details received focused attention during the design and installation phases. The best practice for end detailing of CFRP systems includes a specially designed leak-tight connection through a tie-in at the steel cylinder portion of the PCCP.

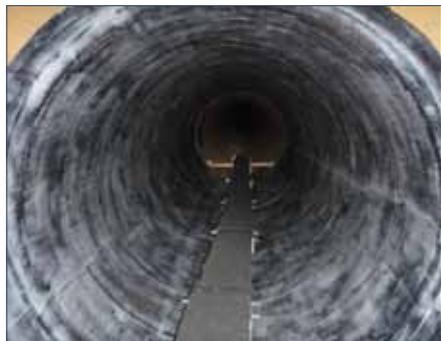
The CFRP installation was completed successfully and safely by Structural Preservation Systems, LLC, using CFRP materials supplied by Structural Technologies, LLC, both Structural Group companies. Photo courtesy of Hector Posada, Tucson Water.

of the CFRP liner and end detailing, the proper cure time is essential prior to reloading the pipeline with water. As part of the Tucson project, the fiber optic cable was reinstalled in the repair region after the cure process was completed. The CFRP installation was completed successfully and safely by Structural Preservation Systems, LLC, using CFRP materials supplied by Structural Technologies, LLC, both Structural Group companies.
